LAND DISTRICT NORTH OF RED RIVER  
SECTION 6, T-17-N, R-4-E  
OUACHITA PARISH, LOUISIANA

**CONTOURS**  
**MILLHAVEN PLANTATION SOUTH**  
OUACHITA PARISH, LOUISIANA

PPM Consultants, Inc. (PPM) was retained by Millhaven Plantation, LLC to conduct a Phase I Environmental Site Assessment (ESA) of two tracts of land comprising Millhaven Plantation-South, located adjoining the intersection of Russell Sage Road and the I-20 Service Road Extension, east of Monroe, Louisiana. The purpose of this assessment was to identify recognized environmental conditions in connection with the property by means of interviews, review of record information, and site reconnaissance. The environmental assessment was conducted in conformance with the scope of American Society for Testing and Materials (ASTM) Standard Practice E 1527-05.

# **WETLANDS INVESTIGATION REPORT**

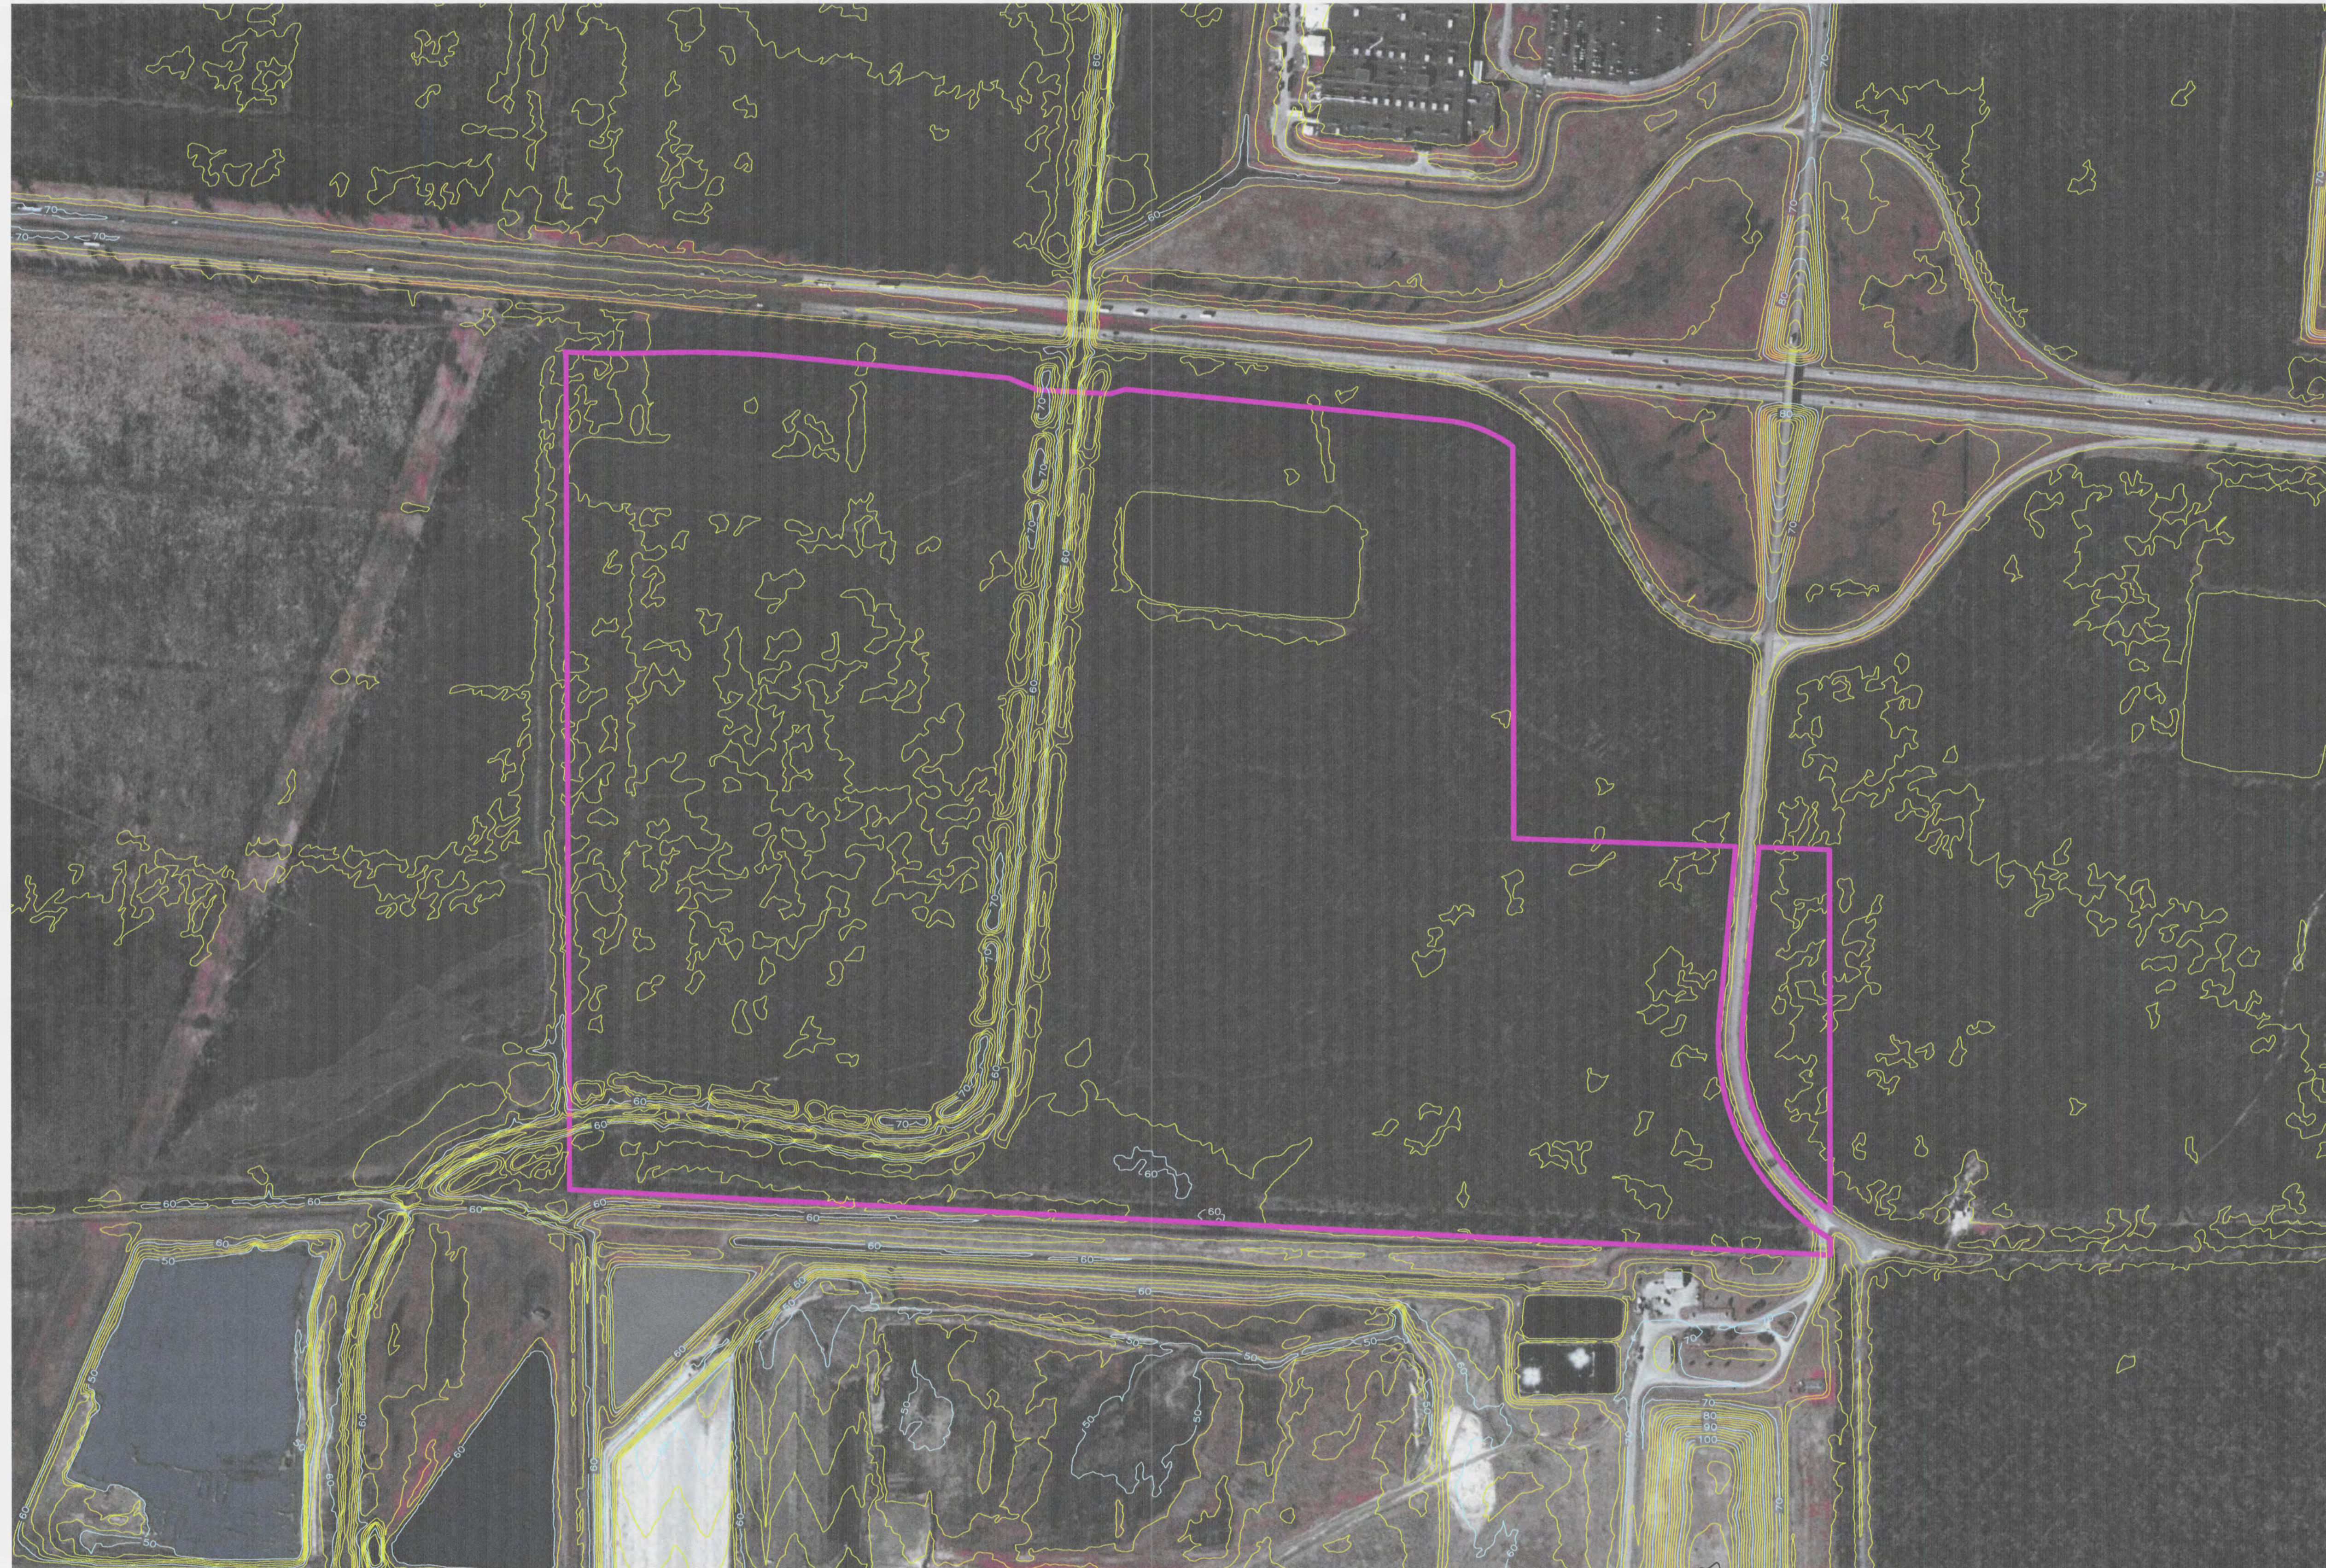
NOTE: BOUNDARY INFORMATION SHOWN IS FOR INFORMATIONAL PURPOSES ONLY. THIS PLAT DOES NOT REPRESENT A BOUNDARY SURVEY.

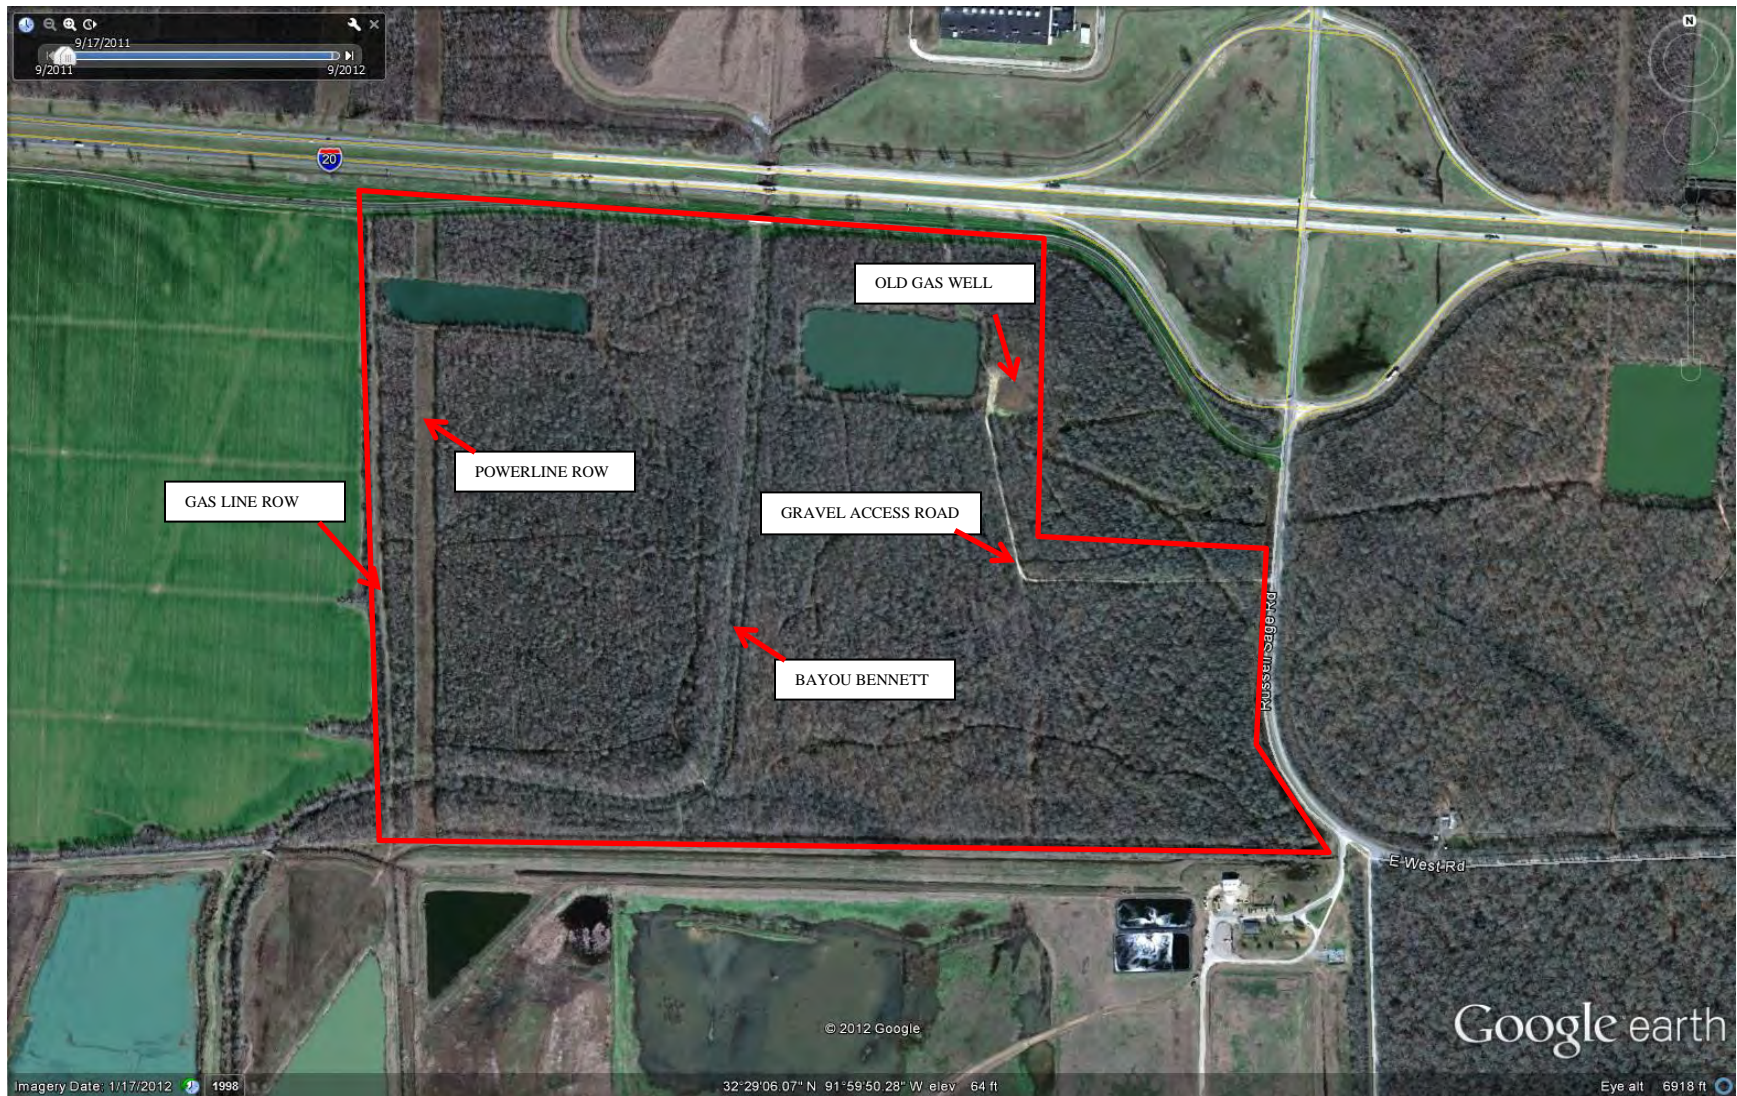
EXHIBIT 3. SUBJECT PROPERTY ON GOOGLE EARTH (2009 IMAGERY)

EXHIBIT 2. SITE LOCATION MAP

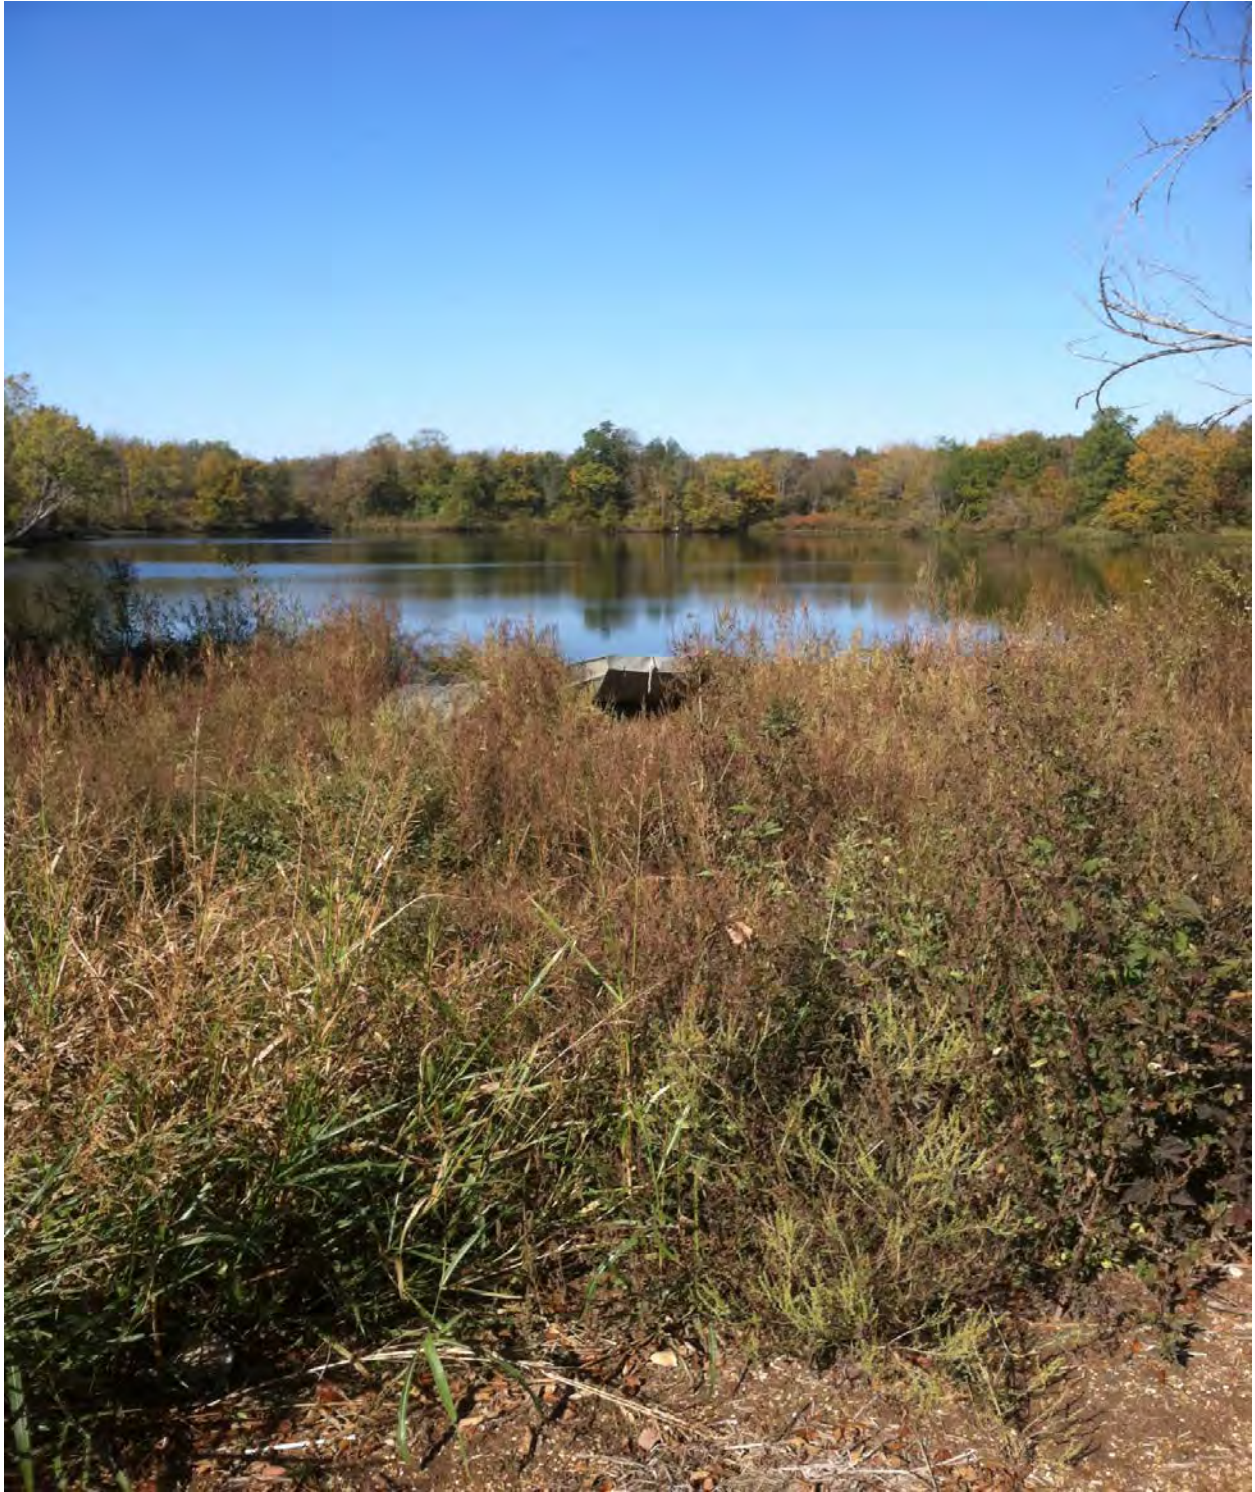
EXHIBIT 6. EASTERN POND

<p>appear to be connected to other bodies of water. Both ponds are remnants of borrow pits that were dug for fill dirt during construction of Interstate 20 circa 1967. The ponds appeared free of solid waste, and PPM did not observe sheens or odors. PPM did observe a skeet thrower positioned along the east bank of the East fish pond. PPM also observed used shotgun shells and wading indicative of shooting events over and/or near the east pond.</p> <p>Bennett Bayou flows from north to south and is located along the western third of Tract 1. PPM observed the bayou at six points along the banks, under the new bridge, approximately 100 yards downstream of the new bridge, halfway down the Bayou's course across the property, immediately downstream of the portable bridge, at the power line ROW, and at the gas line ROW. PPM did observe a sheen on water near the gas line ROW; however, there were no indications of petroleum hydrocarbons.</p>

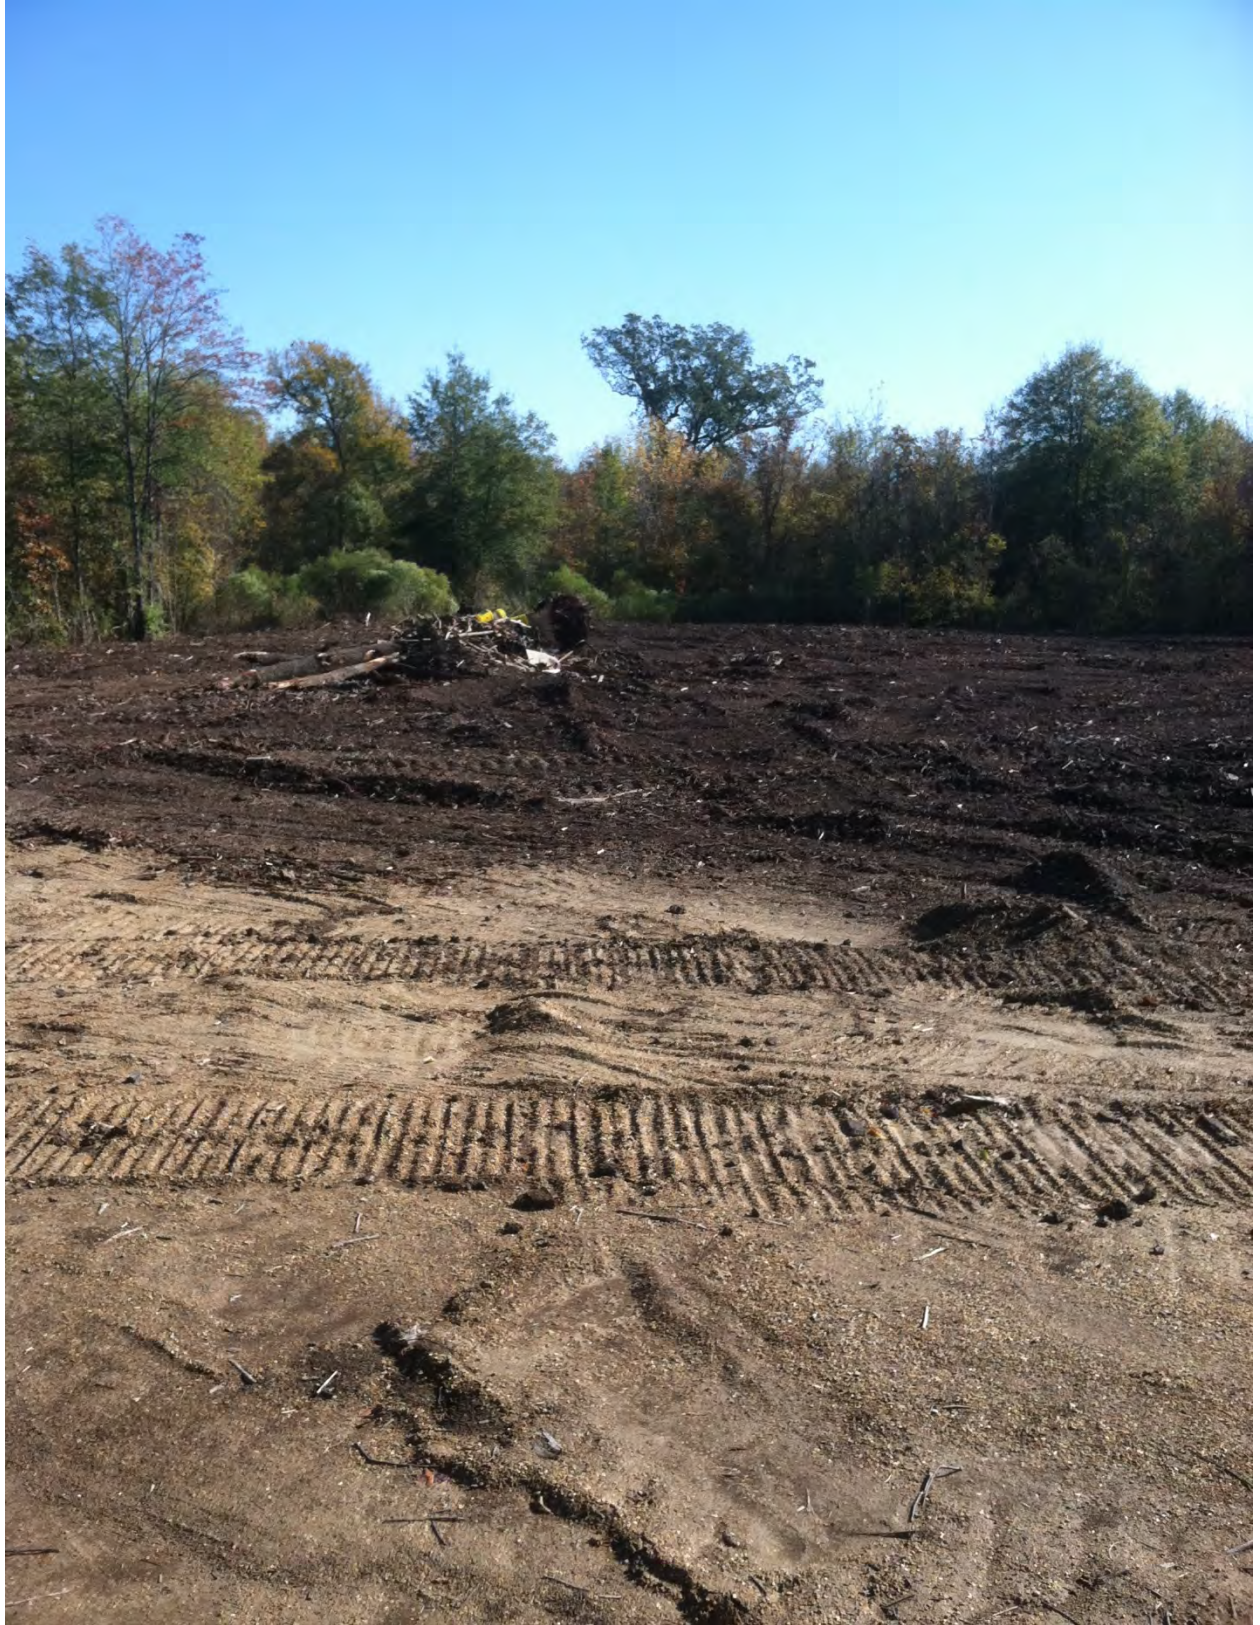
EXHIBIT 8. OLD GAS/OIL WELL SITE

- Fill material. Fill material consisting of soil and debris was observed on the eastern half of the former natural gas well pad. According to the current owners, the material was generated during the construction of the I-20 Service Road Extension; however, documentation of a laboratory analysis on the soil was not provided. Unless laboratory analytical data is provided to document the absence/presence of contamination in fill material on site, the fill material is considered to represent a recognized environmental condition.

6	<p>PPM did not observe well casings or wells during the site visit; however, a former well pad was observed on Tract 1. There was no evidence of staining; however, fresh fill dirt had been spread at the site.</p>
8	<p>A discarded automotive fuel tank was observed on Tract 1; however, PPM was unable to identify the contents. No staining was observed in the area surrounding the fuel tank.</p>
10,11	<p>Several empty 5-gallon buckets of tractor hydraulic fluid were observed at two points on Tract 1; in the refuse pile near the former well pad, and at the main entrance to the facility off Russell Sage Road. The buckets formerly contained a hazardous, petroleum product. There was no evidence of leaks, staining, or free product around any of the discarded buckets.</p>
12	<p>A discarded automotive fuel tank was observed near the main entrance to Tract 1. However, during the initial site visit, PPM was unable to identify its contents. The tank appeared empty, and there was no evidence of staining, free product or petroleum hydrocarbon odor.</p>

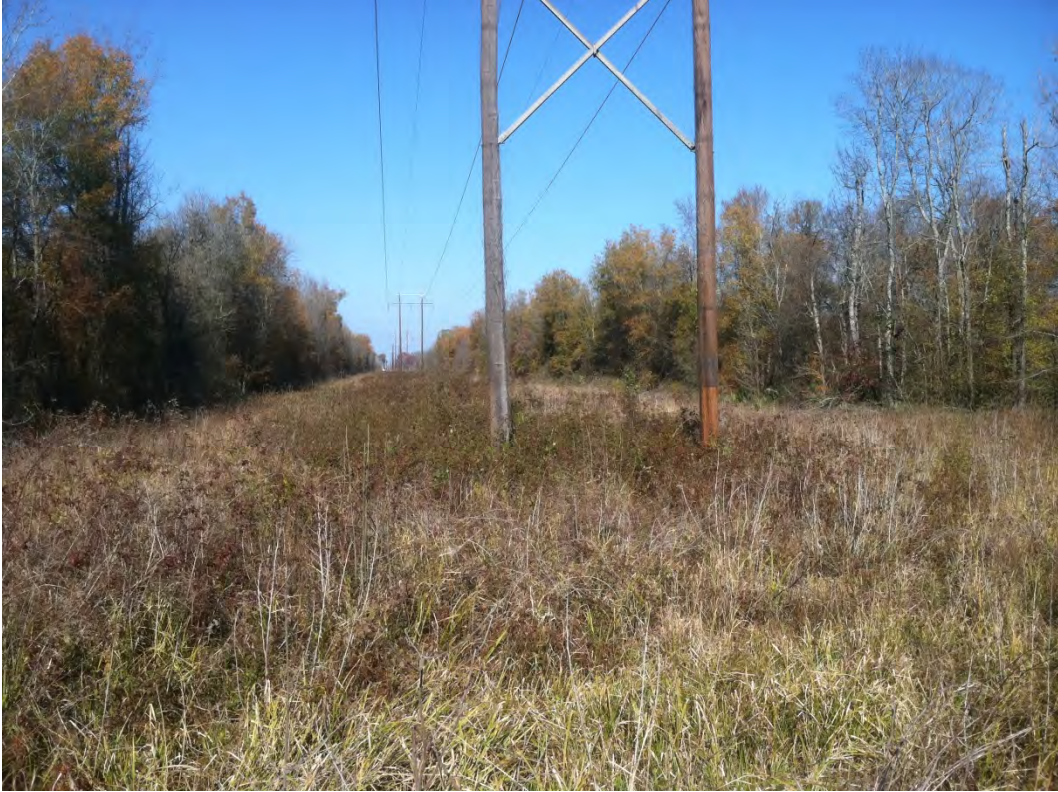
EXHIBIT 9. POWERLINE TRANSMISSION ROW.

- ACTUAL LOCATION OF ABANDONED GAS WELL UNKNOWN TO SURVEYOR. LOCATION SHOWN WAS IN CENTER OF CLEARED PAD. SITE WAS ABANDONED BY CARUTHERS PRODUCING, CO. IN LATE 2010.

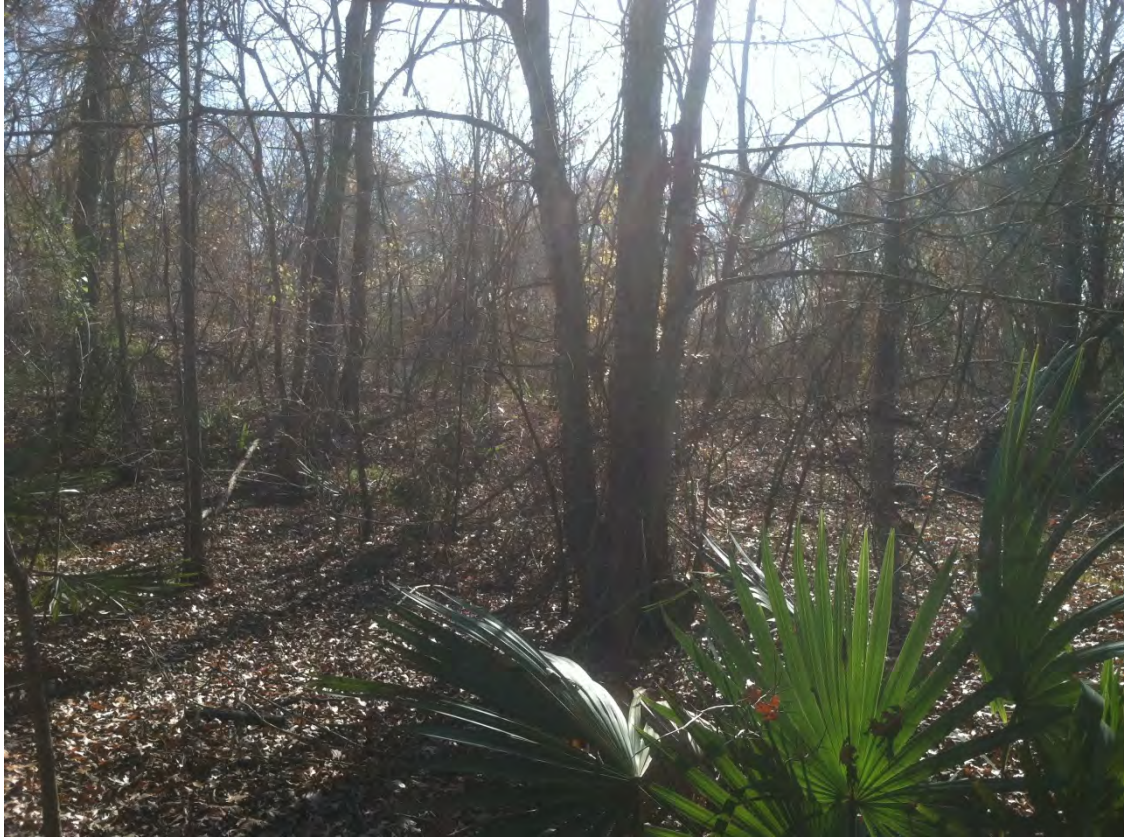
EXHIBIT 11. BOTTOMLAND HARDWOOD FOREST

EXHIBIT 10. NATURAL GAS PIPELINE ROW

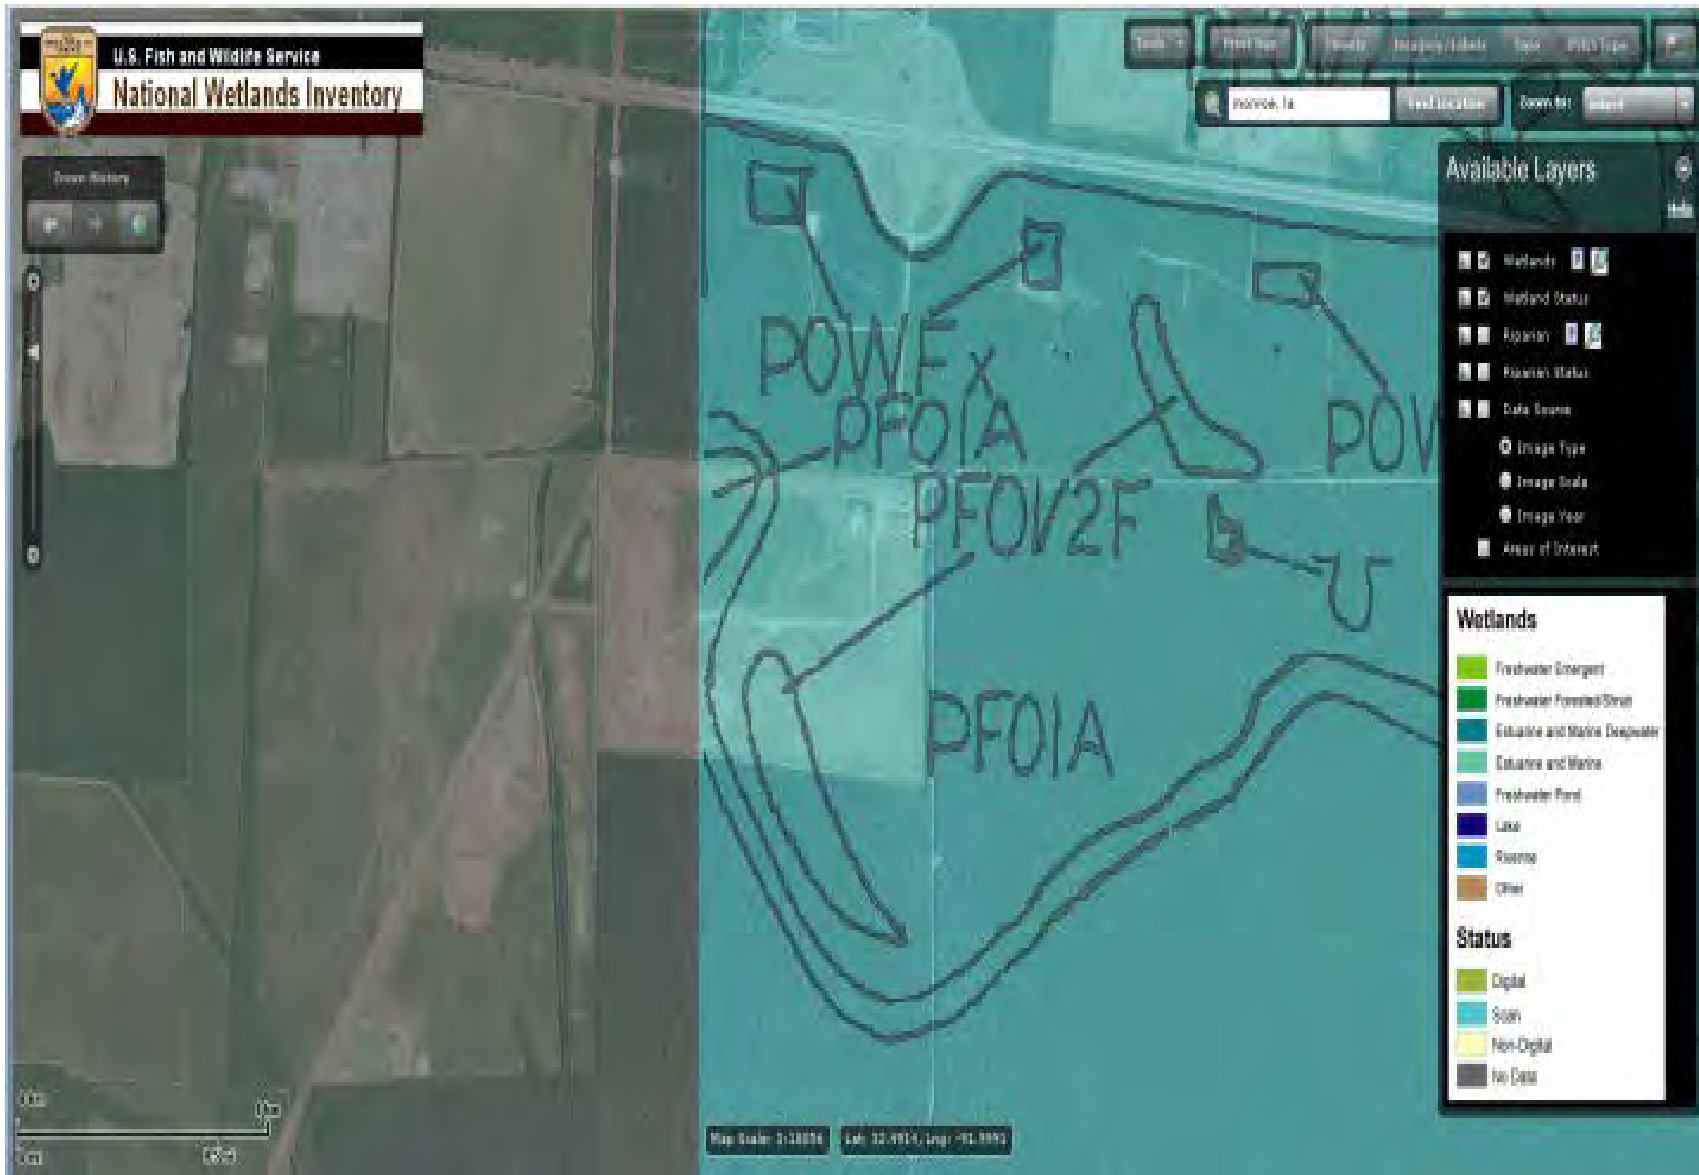
EXHIBIT 14. USFWS NATIONAL WETLAND INVENTORY MAP

Ouachita Parish, Louisiana (LA073)			
Map Unit Symbol	Map Unit Name	Acres in AOI	Percent of AOI
Hb	Hebert silt loam	3.4	1.2%
Pe	Perry clay, occasionally flooded	261.3	91.6%
Pr	Portland clay	15.4	5.4%
W	Water	4.4	1.5%
<b>Totals for Area of Interest</b>		<b>284.6</b>	<b>100.0%</b>

## EXHIBIT 13. 2 SOIL SURVEY MAP
