WETLANDS INVESTIGATION REPORT

I-20 South Tract Highway 594 and Interstate 20 Ouachita Parish, Louisiana

December 5, 2012

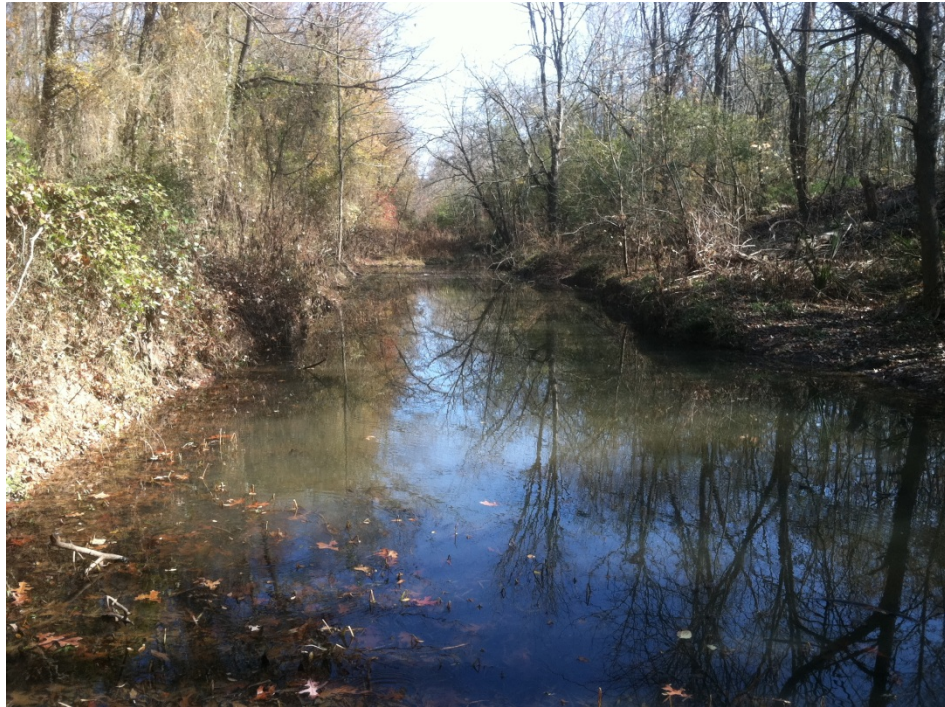
EXHIBIT 4. BENNETT BAYOU SOUTHWEST CORNER

The subject property is almost 100% homogeneous bottomland hardwood forest. Part of the Russell Sage Wildlife Management Area is located less than one-quarter mile to the east of the southeastern corner of the subject property. A Waste Management facility was located adjacent and south of the subject property. Bennett Bayou crosses through the site beginning at the southwest corner heading east and then turning north dissecting the subject property as it continues north under I-20 (Exhibits 4 and 5). Bennett Bayou has been channelized and straightened along most of its length through the subject property with spoil located on both sides of the channel. The spoil ranges from approximately 10-15 feet above the bank top and from 30-40 feet wide.

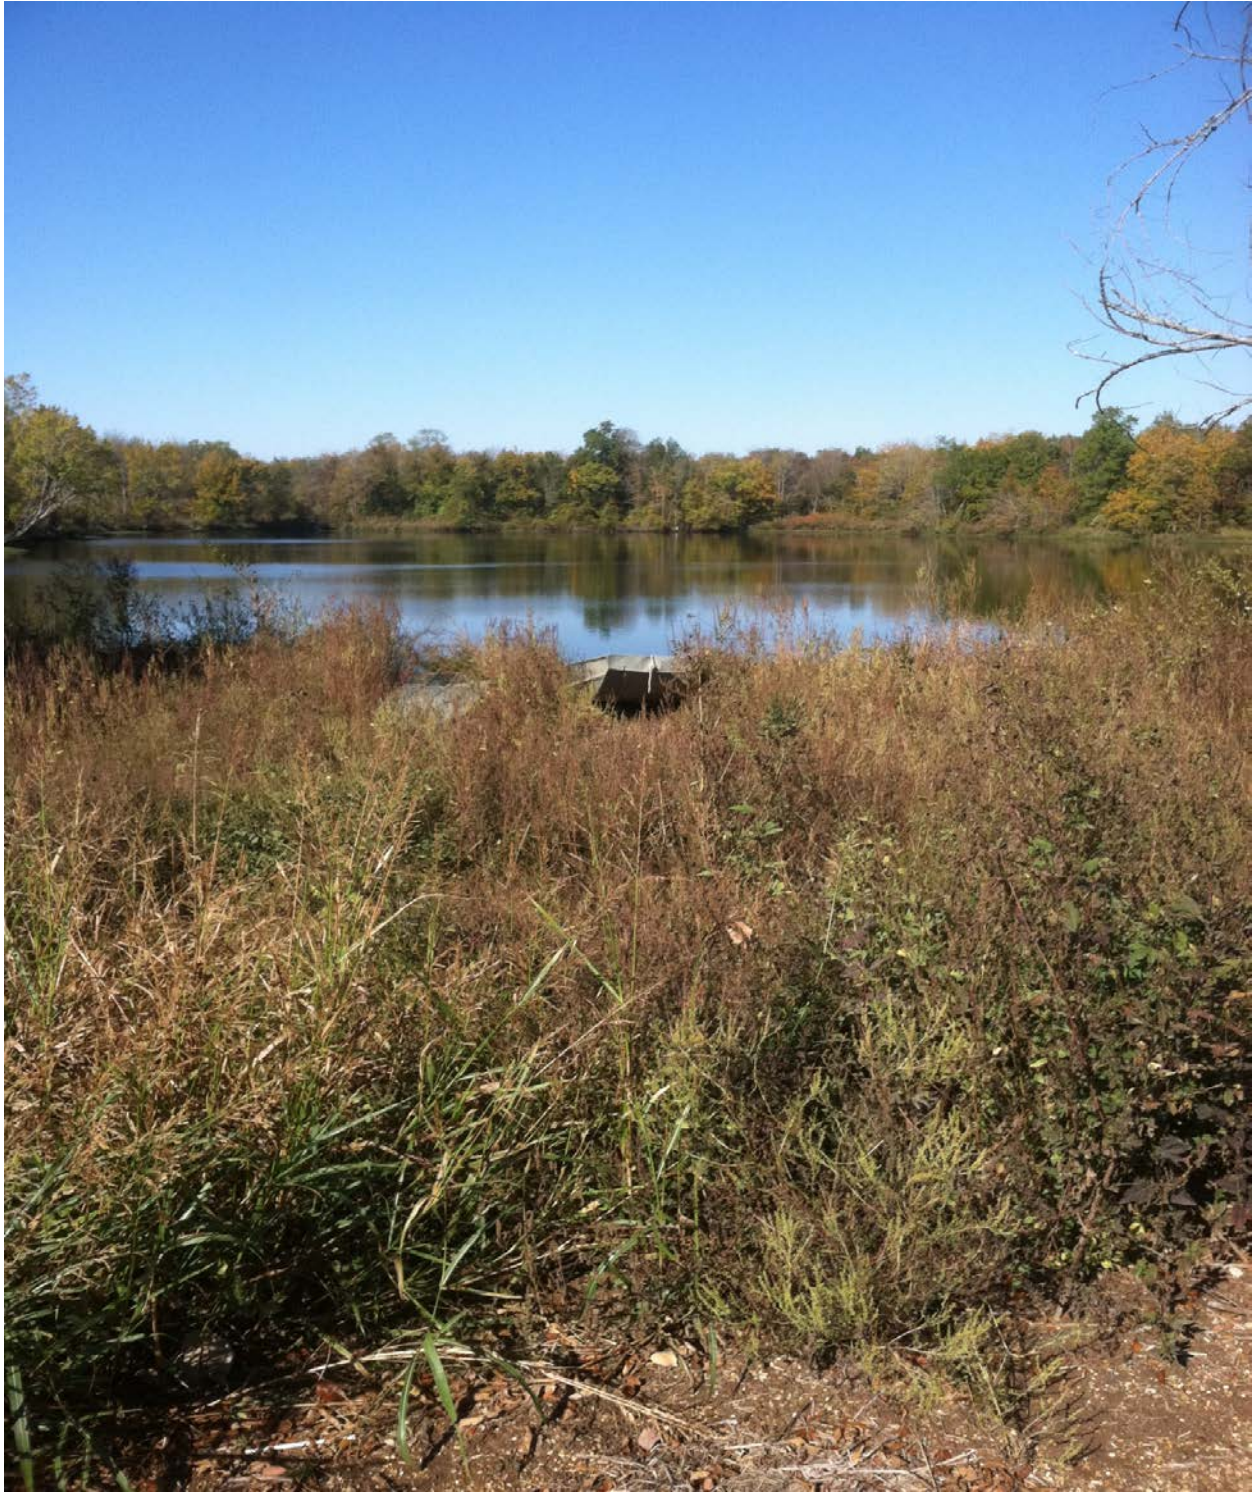
EXHIBIT 6. EASTERN POND

According to the USDA Quadrangle mapping there was a remnant of Gourd Bayou along a small section of the very southern section of the subject property. This remnant channel was most likely significantly impacted by the activities on the adjacent landfill which borders the subject property to the south. There were two ponds located on the north portion of the property that were created from borrow areas during the construction of I-20 (Exhibits 6 and 7).

There were two ponds noted on the site. These ponds were created back in the 1960s from borrow used to build Interstate 20. The banks are 3:1 or greater with little or no emergent or submergent wetland fringe. The eastern pond was 6.4 acres in size and the western pond was 4.0 acres in size.

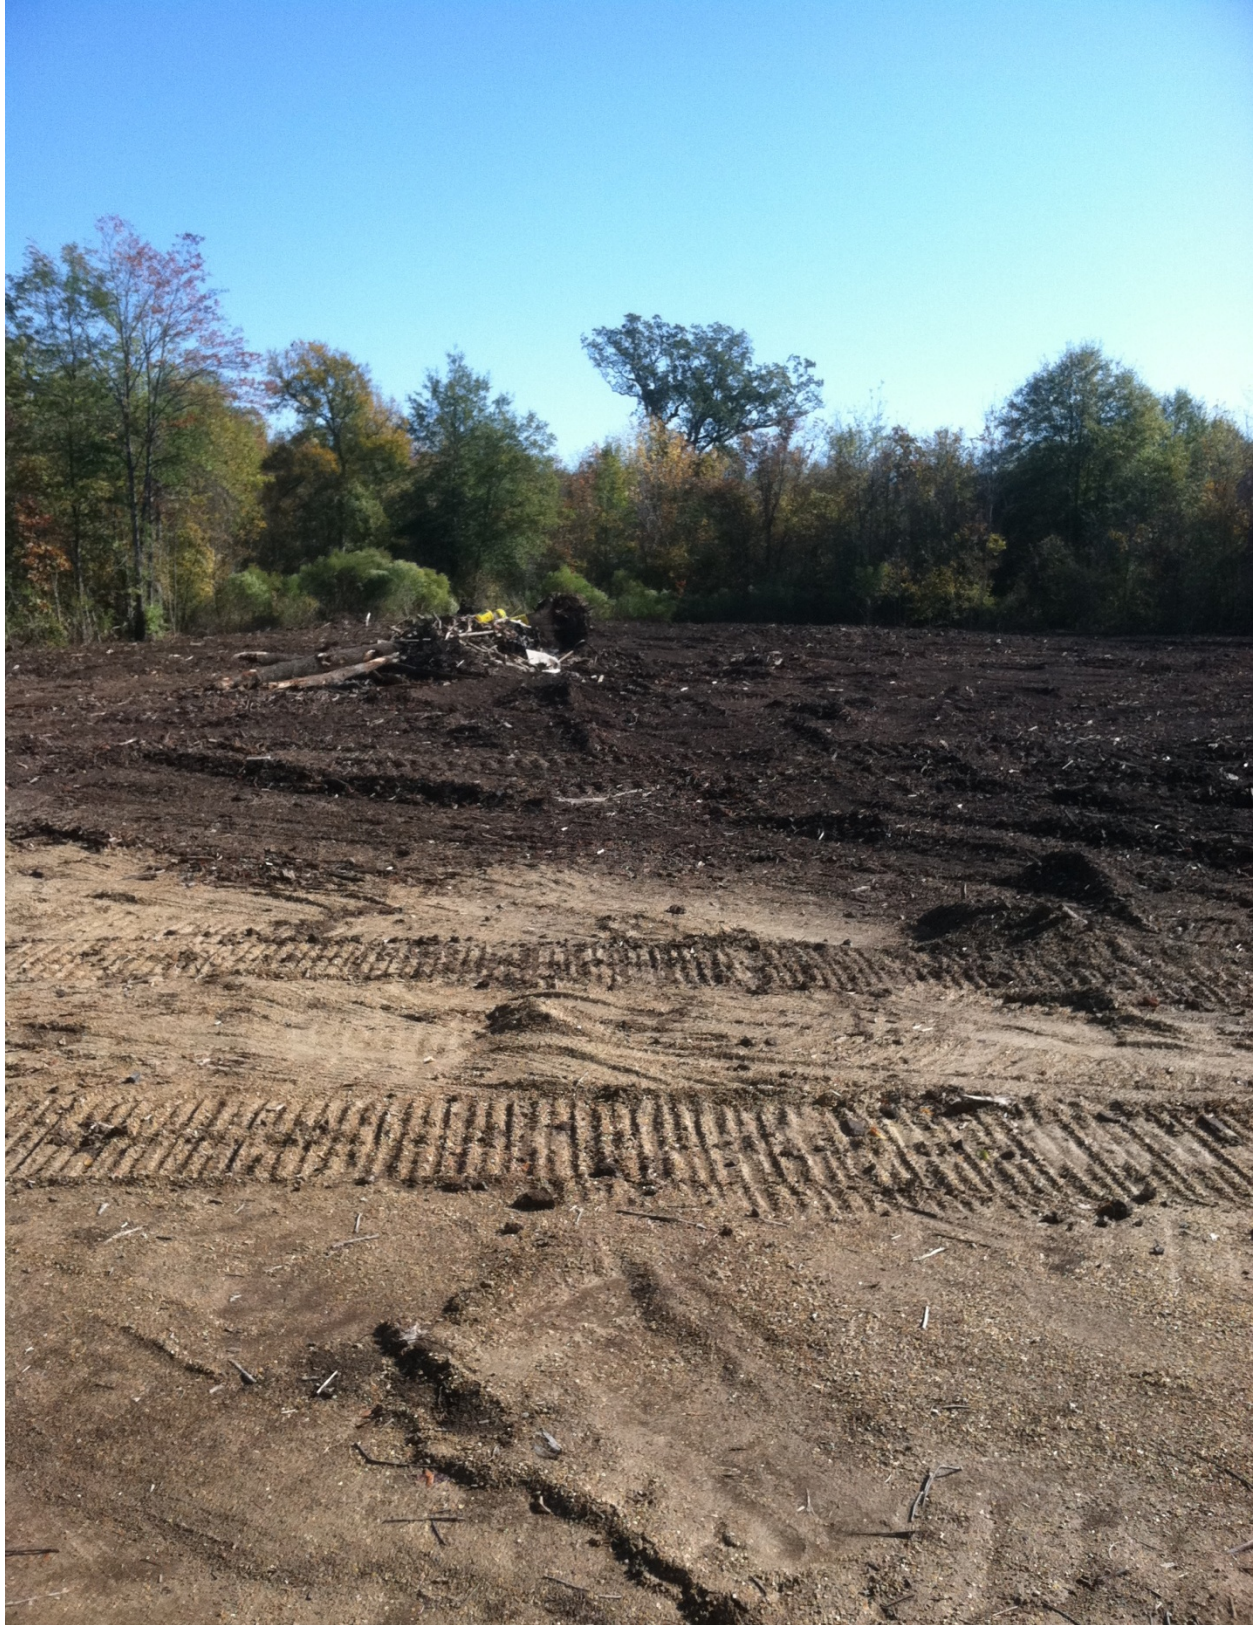
EXHIBIT 8. OLD GAS/OIL WELL SITE

Improvements on the subject property included a gravel road that leads from Highway 594 to the easternmost pond. Adjacent to the larger pond, at the end of the gravel road, there was a historic fill area that may have been associated with a former oil or gas well facility (Exhibit 8). There was an overhead transmission line row and a gas pipeline row located along the far west side of the property (Exhibit 9 and 10). Both of these utilities run north and south across the entire site. There are abandoned dirt roads throughout the subject property that were apparently used as hunting access roads; most of which are not passable by anything other than an ATV.

Gas well pad site = 0.62 acres

Johnson grass was the dominant plant but vegetation was recently disturbed as well as historically disturbed by oil/gas activities.

soils were dominated by gravel/sand/silt soils that were part of original and subsequent fill materials for the histoic oil/gas pad site.

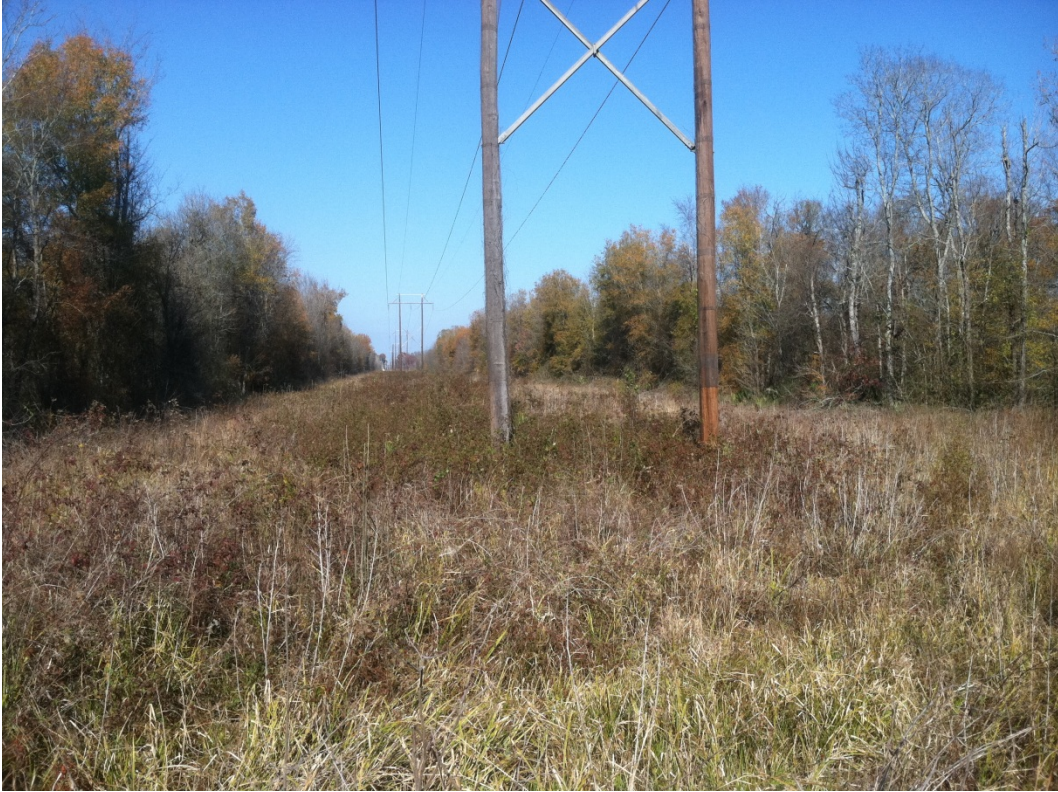
EXHIBIT 9. POWERLINE TRANSMISSION ROW.

The natural gas pipeline ROW is regularly maintained with only short grasses and it is apparently used as a property access road at times. The overhead power transmission line ROW is more overgrown but still maintained either annually or semi-annually with no woody vegetation noted, other than some small sapling black willows (*Salix nigra*).

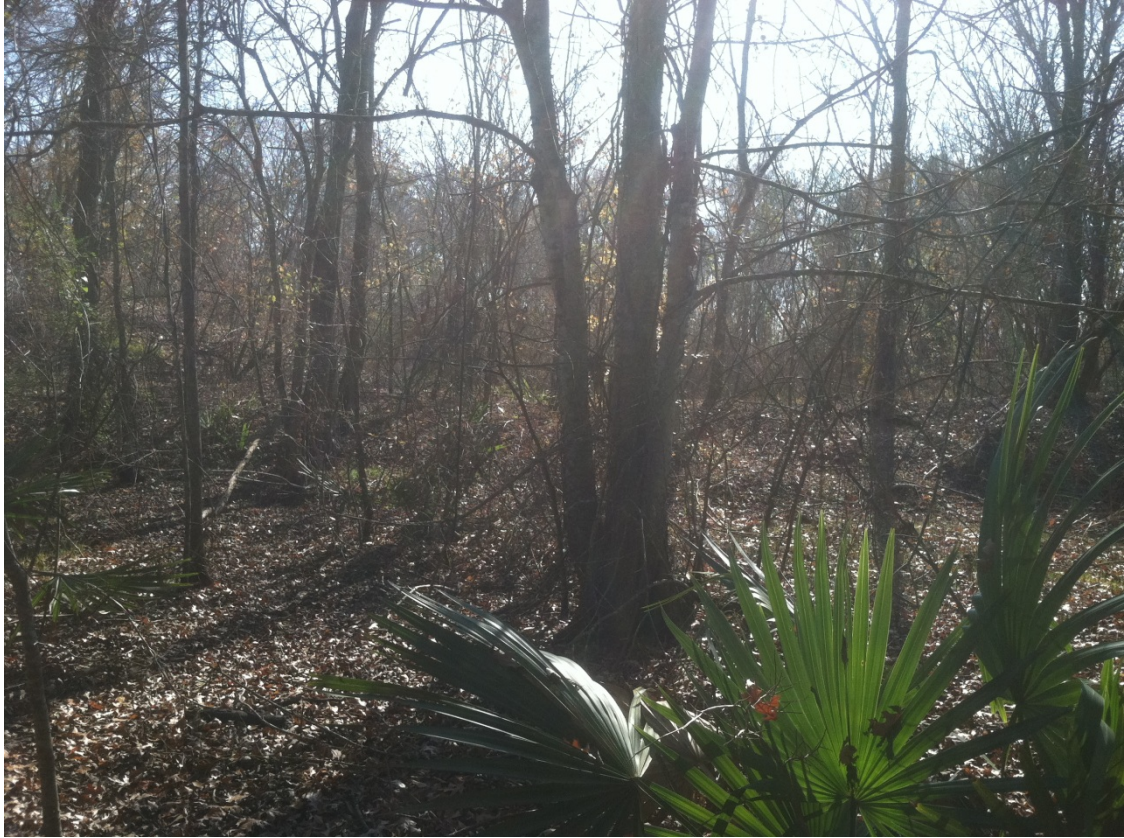
EXHIBIT 11. BOTTOMLAND HARDWOOD FOREST

The forest was fairly homogeneous due to the flat topography (Exhibits 11 and 12). The dominant canopy species were water oak (*Quercus nigra*), willow oak (*Q. phellos*), delta post oak (*Q. stellata*), cherry bark oak (*Q. pagoda*), green ash (*Fraxinus pennsylvanica*), hackberry (*Celtis laevigata*), water hickory (*Carya aquatica*), and cedar elm (*Ulmus crassifolia*) and winged elm (*Ulmus alata*). Midstory and herbaceous species were minimal due to the dense canopy with the exception of dwarf palmetto (*Sabal minor*).

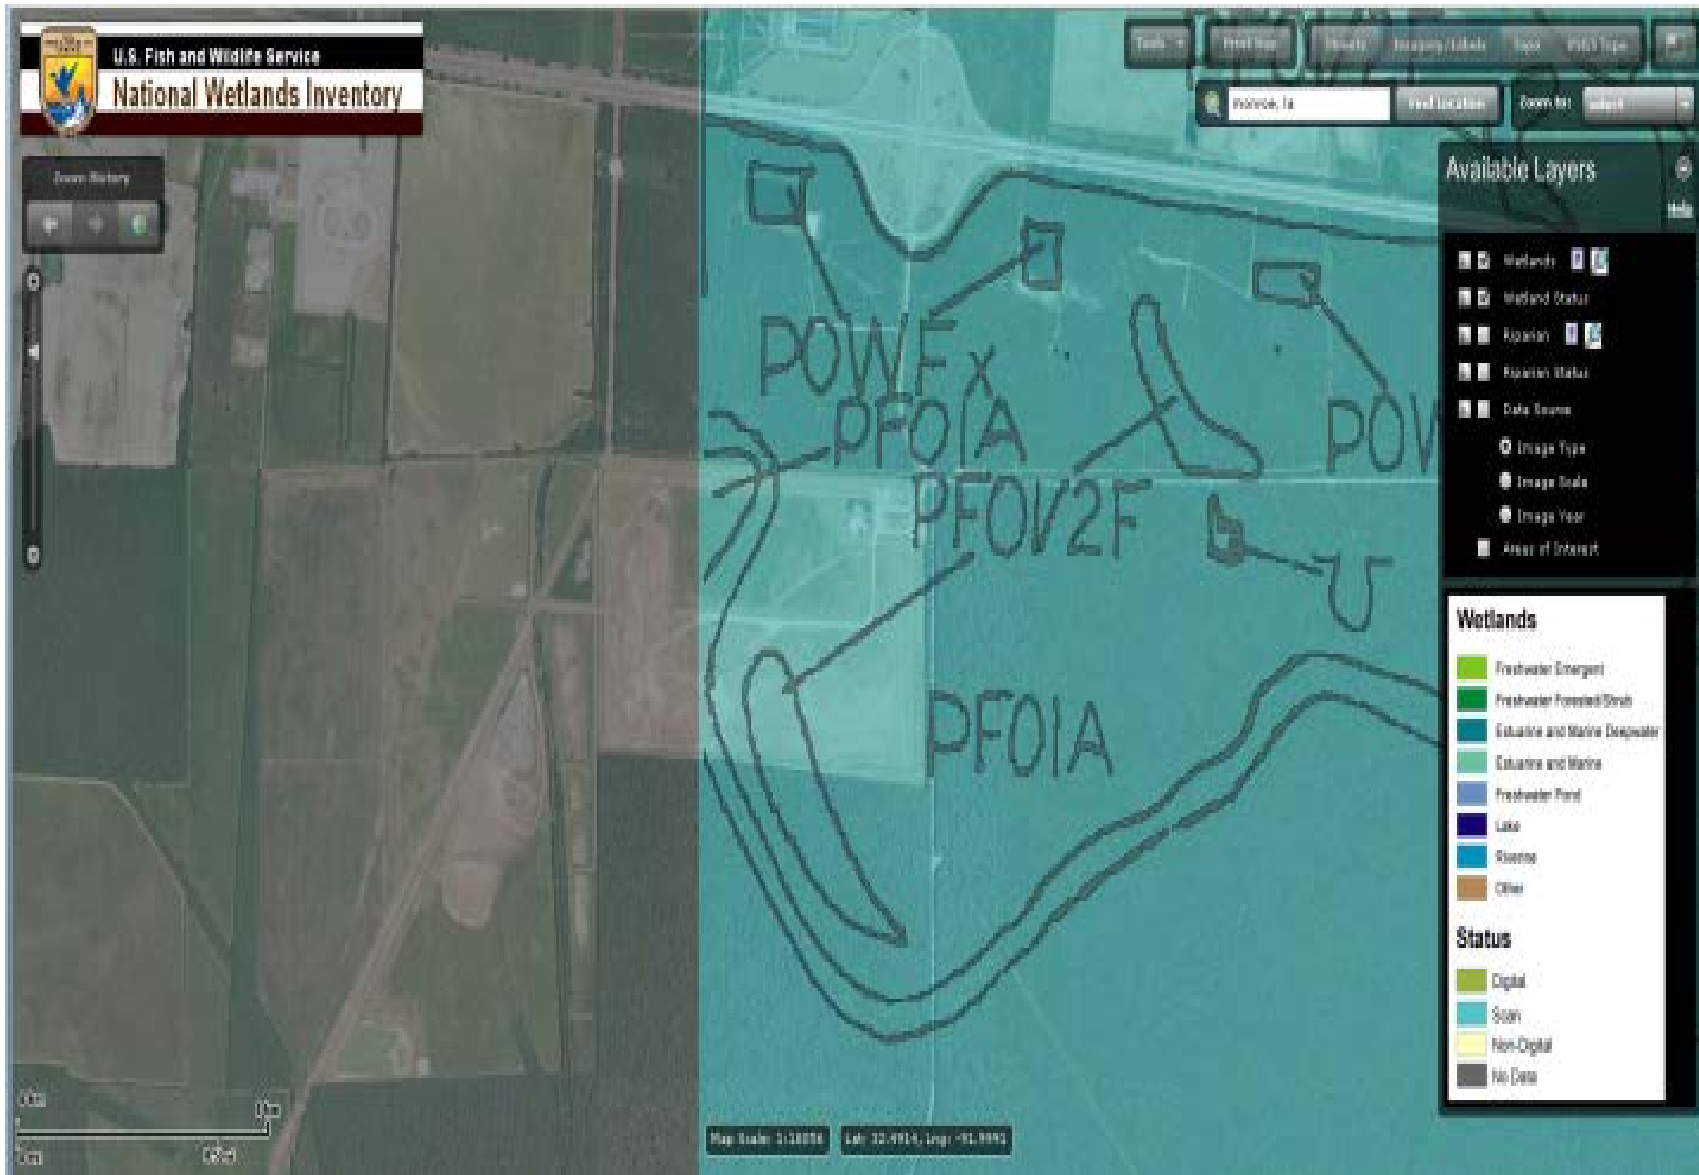
EXHIBIT 14. USFWS NATIONAL WETLAND INVENTORY MAP

A review of the USFWS National Wetland Inventory mapping showed most of the tract as Palustrine Forested, broad-leaved deciduous vegetation, temporarily flooded (PFOIA, Exhibit 14).

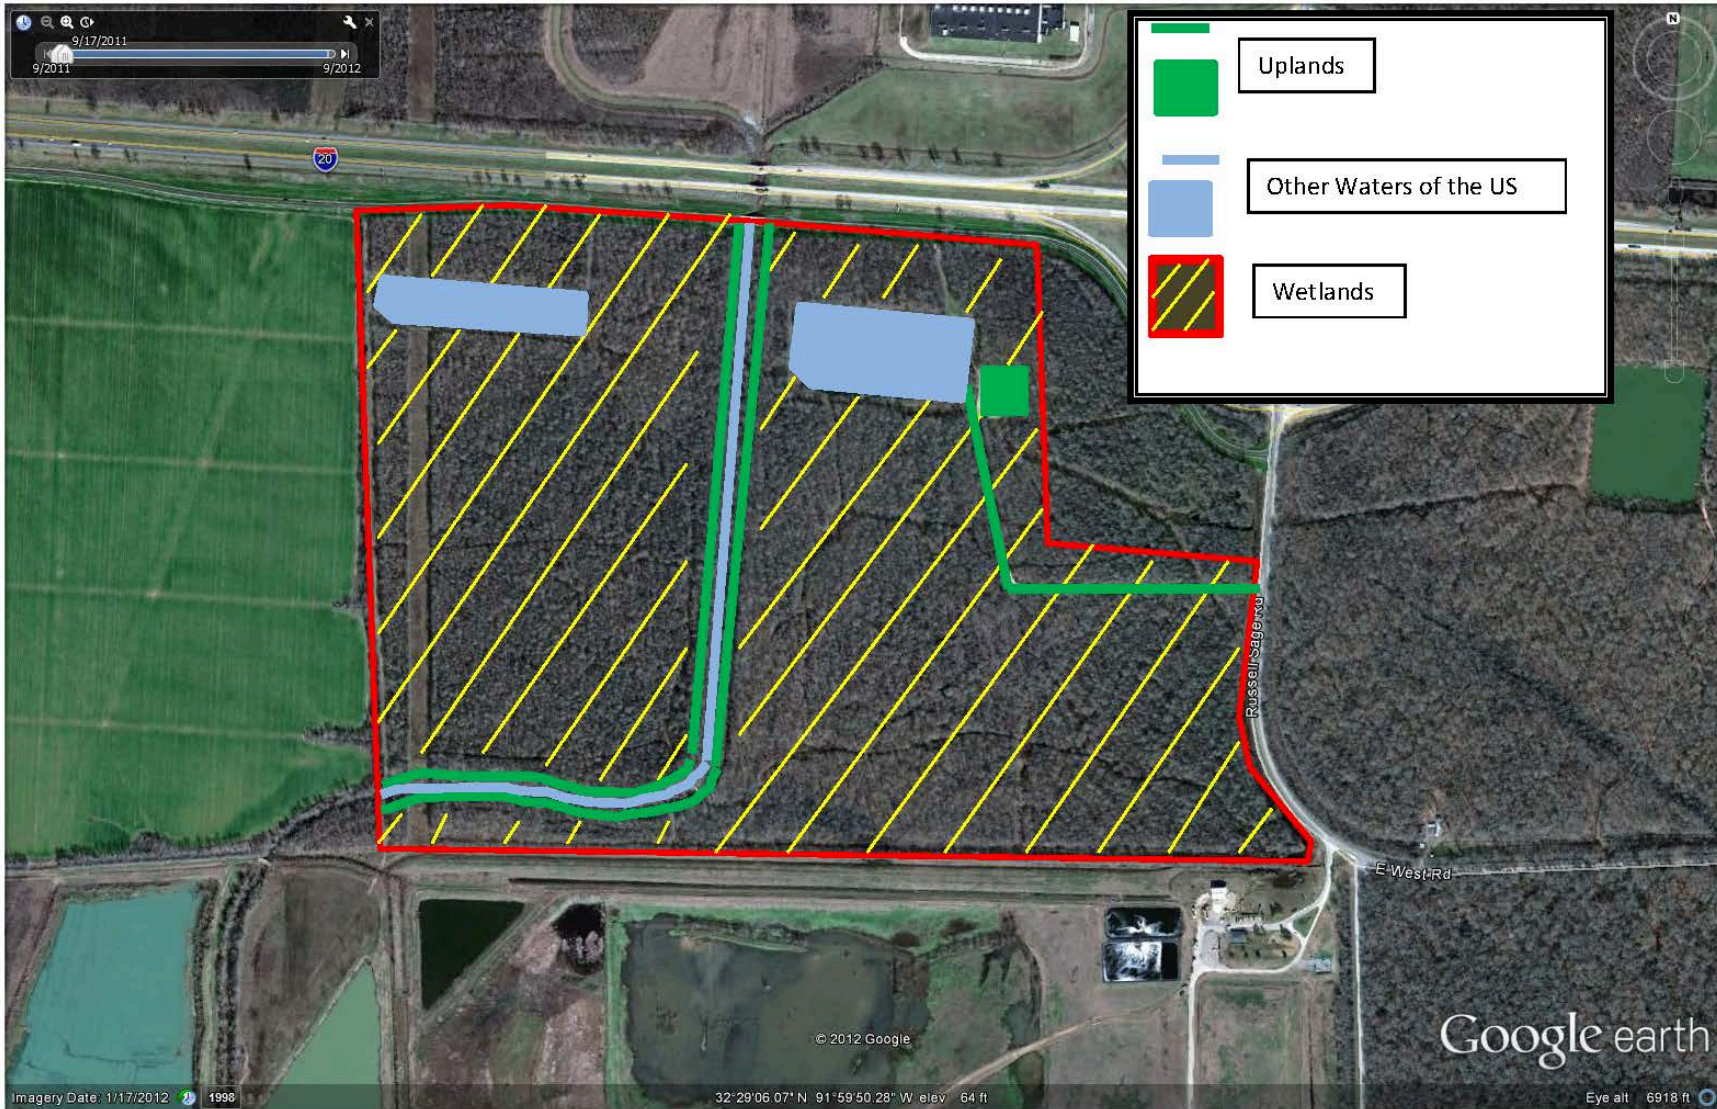
EXHIBIT 15. WETLANDS MAP

Wetlands: Based on the site reconnaissance, and a review of CIR photography, historical aerial photography, USFWS National Wetland Inventory mapping, the USDA Soil Survey for Ouachita Parish, and 7.5 minute topographic quadrangle maps, and a site visit, most of the subject property is forested wetlands. Positive hydrological conditions, vegetation and hydric soil characteristics were clear and distinct throughout the site.

Uplands: The areas of exception were the borrow area from dredging of Bennett Bayou, the developed road and abandoned oil/gas site pad. The uplands were noted as such due to historic fill material and continued maintenance. A representative data sheet was prepared for the borrow area uplands adjacent to Bayou Bennett, however the roads and abandoned pad site were considered disturbed and data sheets were not completed since there was rock/gravel fill and no vegetation.

Other Waters of the US: Bayou Bennett is a manipulated perennial stream which extends through the property for approximately 4,029 feet. The nearest Navigable Waterway is Bayou Lafourche which is approximately 5.8 river miles away and 3.8 aerial miles away. The average high water mark was three feet and the average width at the ordinary high water mark was approximately 30 feet. The bank slopes were typically 3:1 or greater with defined bed and bank. At the time of the visit the water was below the ordinary high water mark and there was no flow noted. The bottom was consolidated silt with riffles and pools created by debris and scouring. There was little vegetation.

Exhibit 15 shows the wetlands, uplands, and "other waters" located within the subject property limits. Wetland Data Forms are located in the Appendix.
